INVESTIGATION INTO THE MECHANICAL PROPERTIES AND METAL CREAKS OF A DIESEL LOCOMOTIVE WHEEL

Abstract. After JSC 'Lithuanian Railways' (AB 'Lietuvos geležinkeliai') bought new Siemens ER20 CF locomotives produced in Western Europe and brought them into service, some of them have already done about 170–200 thousand km that caused the appearance of indentations of an inadmissible size (the depth is more than 3 mm, the length – 10 mm) the elimination of which turning cutting results in up to 20 mm loss of a wheel. Having grounded off the metal layer of indentation depth, indentation reappears (metal 'flakes off') and needs to be removed by re-turning cutting the wheel. The purpose of the current investigation is to determine whether there is a reason to claim that the cause of wheel surface crumbling could be a chemical composition of the wheel or wheel-to-rail hardness ratio. The carried out investigations have revealed that there is no reason to claim that the cause of wheel surface crumbling could be the chemical composition of the wheel or wheel-to-rail hardness ratio.

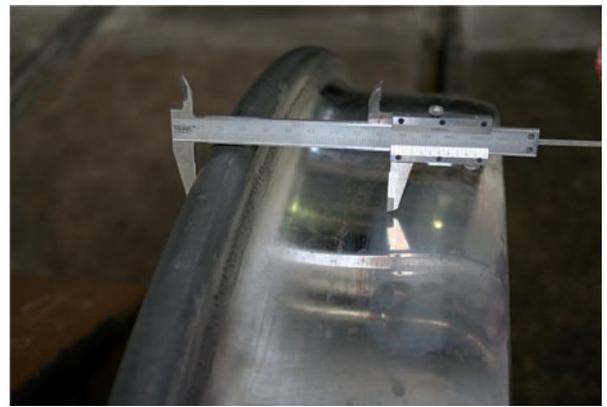
Fig. 3. The layout of the failures of the rolling surface

Having carried out an exhaustive inspection, 39 failures of the rolling surface on both wheels were noticed. The absolute majority of wheel rolling surface defects are superficial and not located in the rolling centre (70 mm from the wheel inner surface) but 20–30 mm outward (towards the thin cone part) from it (see Fig. 3).

Only two of the identified 39 failures are on the rolling centre.

2. The absolute majority of wheel rolling surface defects are not located in the rolling centre (70 mm from the wheel inner surface) but 20–30 mm outward from it. Only two of the identified 39 failures are in the rolling centre.

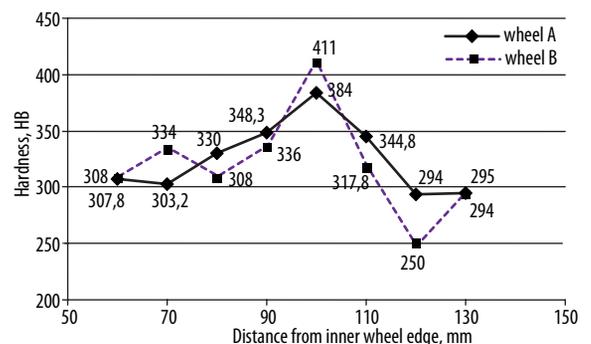
Fig. 5. Measurement results for the hardness of the rim rolling surface

According to the technical certificates of diesel locomotives, the hardness of their wheel surface fluctuate from 279 to 292 HB (complies with EN13262:2004 requirements). According to GOST 398-96 (ГОСТ 398-96), hardness must be 269–275 HB depending on a steel grade. The analysis of Fig. 5 shows that the maximum surface hardness of the tested wheel (411 and 384 HB) is not in the rolling centre (its distance from the inner wheel edge makes 70 mm) but 30 mm further. The elevated hardness area is at approximately 90 to 110 mm distance from the inner wheel edge. It corresponds to the appearance area for the majority of cracks. Therefore, it can be suggested that cracks causing crumbling appeared due to deforming metal hardening.

6. The maximum surface hardness of the wheel under investigation is not on the rolling centre but 30 mm further. The elevated hardness area corresponds to the appearance area for the majority of cracks.
7. Hardness decreases deepening away from the rolling surface of a non-turning cut wheel. At 5 to 25 mm depth, hardness decrease equals to an average of approximately 1.5 HB/mm.
8. In wheel metal, hardness is nowhere lower than 255 HB which means that during the process of production, hardness requirement complied with EN13262:2004.
9. Having carried out investigations, it has been found that there is no reason to claim that the cause of wheel surface crumbling could be the chemical composition of the wheel or wheel-to-rail hardness ratio.

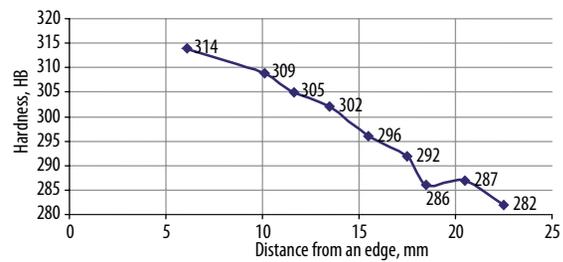
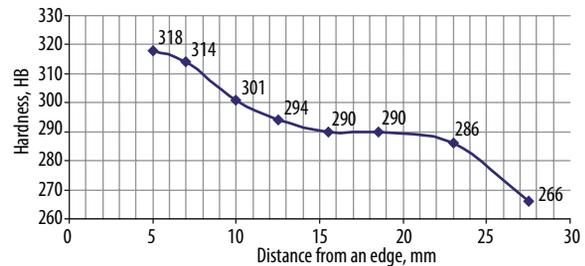
By comparing two diagrams of lateral wheel hardness, we can notice that even though they are different, they also have a common feature: **edge hardness decreases** in a direction away from the wheel rolling surface. The mean value of hardness decrease under the rolling surface (at 5 to 25 mm depth) equals to 1.5 HB/mm. However, hardness is nowhere lower than 255 HB which means that during production, hardness requirement complied with EN 13262:2004.

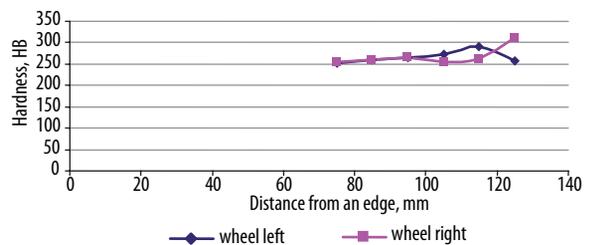
Fig. 9. Hardness distribution in the rolling surface of the wheels

Hardness distribution in the wheel rolling surface (starting from the rolling centre – 70 mm and moving outward the wheel) is almost uniform, however, in the area where metal hardness and cracks (20–32 mm from the rolling centre) were present prior to grinding off, hardness increase in up to 50 HB is noticed after grinding off as well.
