INVESTIGATION INTO THE MECHANICAL PROPERTIES AND METAL CREAKS OF A DIESEL LOCOMOTIVE WHEEL

Abstract. After JSC 'Lithuanian Railways' (AB 'Lietuvos geležinkeliai') bought new Siemens ER20 CF locomotives produced in Western Europe and brought them into service, some of them have already done about 170–200 thousand km that caused the appearance of indentations of an inadmissible size (the depth is more than 3 mm, the length – 10 mm) the elimination of which turning cutting results in up to 20 mm loss of a wheel. Having grounded off the metal layer of indentation depth, indentation reappears (metal 'flakes off') and needs to be removed by re-turning cutting the wheel. The purpose of the current investigation is to determine whether there is a reason to claim that the cause of wheel surface crumbling could be a chemical composition of the wheel or wheel-to-rail hardness ratio. The carried out investigations have revealed that there is no reason to claim that the cause of wheel surface crumbling could be the chemical composition of the wheel or wheel-to-rail hardness ratio.

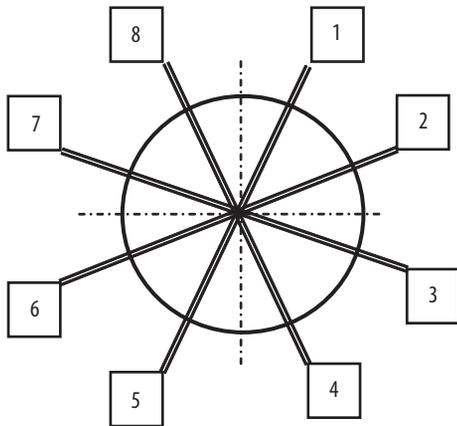
Fig. 2. The diagram of dividing the wheel into sectors

The visual inspection of rim surface defines that a wheel near a reducer is marked with letter A and a wheel further from the reducer – with letter B. Prior to the inspecting wheel rolling surface, every rim is divided into 8 (eight) sectors (see Fig. 2).

Since a wheel is round and has no protruding elements (as a reference base), its division into equal sectors is arbitrary. The division allows defining the relative position of the noticed wheel defects. Having identified

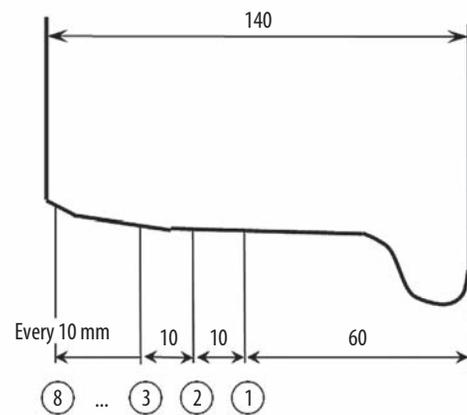
Fig. 4. Areas of surface hardness measurement (1, 2, 3, ..., 8 – hardness measurement areas)

The measurements of wheel rolling surface hardness (Brinell hardness) are carried out using DinaMIC hardness tester. The test rolling metal surface of a wheel ground to the flat surface. In order to measure hardness, the wheel rolling surface is divided into 8 (eight) areas (see Fig. 4).

The distance between the first area and the inner wheel edge is 60 mm, the second area – 70 mm etc. The surface is divided into areas for measurement convenience, measurement results are presented according to the distance from the inner wheel edge. 5 hardness measurements have been carried out in each area at identical intervals and their arithmetic mean value is presented for the report. The generalized measurement results are displayed in Fig. 5.

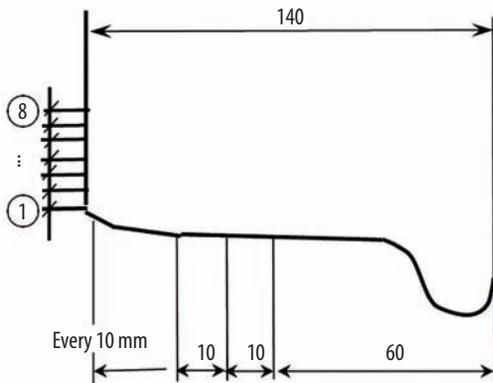
Fig. 6. The diagram of hardness measurement for the lateral wheel surface (1, ..., 8 – hardness measurement areas)

The diagram of lateral hardness measurement for a wheel is shown in Fig. 6.

The hardness of the lateral wheel surface is measured in 8 areas. The measurement results are presented in Figs 7 and 8.

By comparing two diagrams of lateral wheel hardness, we can notice that even though they are different, they also have a common feature: **edge hardness decreases** in a direction away from the wheel rolling surface. The mean value of hardness decrease under the rolling surface (at 5 to 25 mm depth) equals to 1.5 HB/mm. However, hardness is nowhere lower than 255 HB which means that during production, hardness requirement complied with EN 13262:2004.
