INTERLAMINAR AND INTRALAMINAR DAMAGE MECHANISMS OF IMPACT RESISTANT AIRCRAFT MATERIALS UNDER LOW-ENERGY IMPACT

N. Keršienė, A. Žiliukas

Department of Mechanics of Solids, Kaunas University of Technology, Kęstučio 27, LT-44025 Kaunas, Lithuania

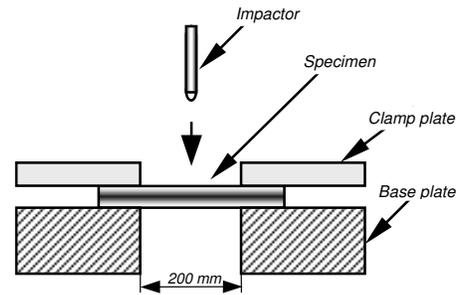
Fig 1. Vertical drop-weight impact test according to Airbus-Norm AITM 1-0010

For low-velocity impact, a vertical drop-weight testing machine with maximum impact energy of 120 J was developed at EADS Corporate Research Center Germany. To measure the impact force and displacement history, a Kistler Press Force Sensor Type 9333 and a Heidenhain Displacement Sensor Type LIDA 100 are mounted. The force transducer has a force capacity of 50 kN. The tests were performed according to Airbus-Norm AITM 1-0010 [1]. The specimen was clamped between steel plates (Fig 1) and the impactor is dropped from a known, variable height, and hence at a known incident velocity, onto a horizontally supported plate target. A variable mass attached to the impactor allows variation of the velocity at a given incident energy. The tip of the impactor has a hemispherical shape and is made of hardened steel $R_m=2000$ MPa according to EN 2760. The impactor head is 15.75 mm in diameter. The height of the impactor was maintained between 344 mm and 1140 mm. Impact tests were performed with nominal impact

energies between 16 and 28 J and impact velocities between 2.54 and 4.63 m/s.

The post-processing of force-time and deflection-time data enables the software to calculate the energy absorbed by the specimen. Nondestructive techniques like visual inspection can be particularly useful in the examination of initiation and pre-damage progression in composite systems.

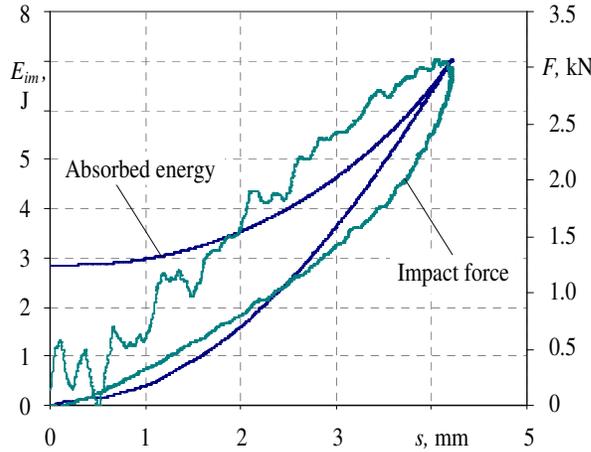
Fig 2. Absorbed energy and impact force plotted against impactor displacement by impact energy of 6 J

A significant proportion of the incident energy in structures is also absorbed through elastic structural response. In the beginning of the impact event, the impact energy is transferred to the specimen. The energy absorbed by the structure during impact (Fig 2) can be calculated as

in which the impulse is equated to the change in momentum of the impactor [12]. Figure 2 shows the transferred energy on the structure of laminates and the contact force plotted against the impactor displacement.

In the case of the non-perforating impact test, the maximum transferred energy of 6 J and maximum impact force of 3.08 kN are located at the maximum impactor displacement of 4.22 mm.

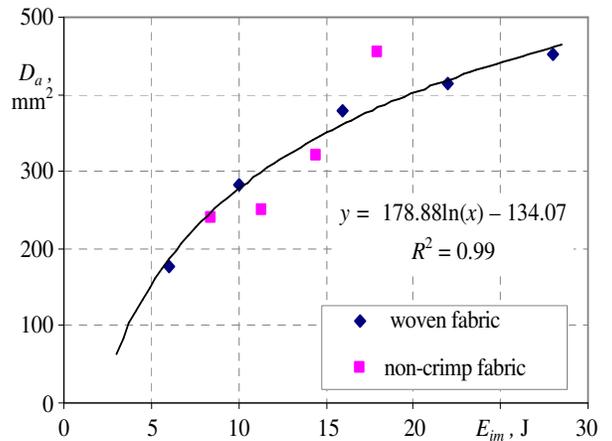
Fig 3. Damaged area, plotted against the impact energy J

The damaged areas, D_a , obtained by visual inspection of the specimens with woven fabrics and multiaxial non-crimp fabric reinforcement, are plotted as a function of the incident energy in figure 3 [6]. The increase in delaminated area with increasing impact energy is lower in the case of woven-fabric laminated specimens. These results agree with previous impact studies in which the higher impact damage resistance of woven fabrics laminates is connected with its interlaminar and intralaminar fracture resistance, which is higher than cross-ply laminates [4]. This reduced radial expansion of damage can be attributed to the self-confinement of interlaced rovings.

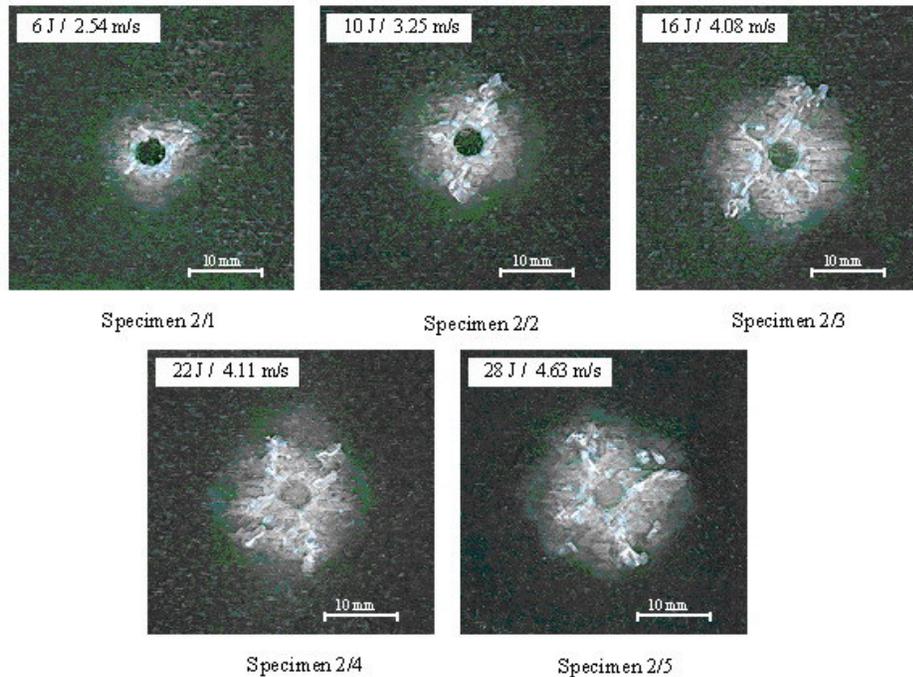
Fig 4. Front face view of woven glass-fiber reinforced composites showing damage modes at impact energies between 16 and 28 J and impact velocities between 2.54 and 4.63 m/s

The front-face damage in woven E-Glass/epoxy composite systems is presented in figure 4. At the low incident energy of 6 J, a small permanent indentation

occurs under the impactor. An area of delaminated zones forms on the front-face at the roving ‘cross-over’ points, which is small in comparison to the internal delamination. The internal and front-face delamination areas increase rapidly, whilst the permanent indentation becomes more severe. The front-face delamination with matrix damage becomes pronounced in a central cross-shaped area that follows the weave directions, and internal delaminations become irregular in shape. Contact force at 22 and 28 J causes front-face fibre shear-out failure.

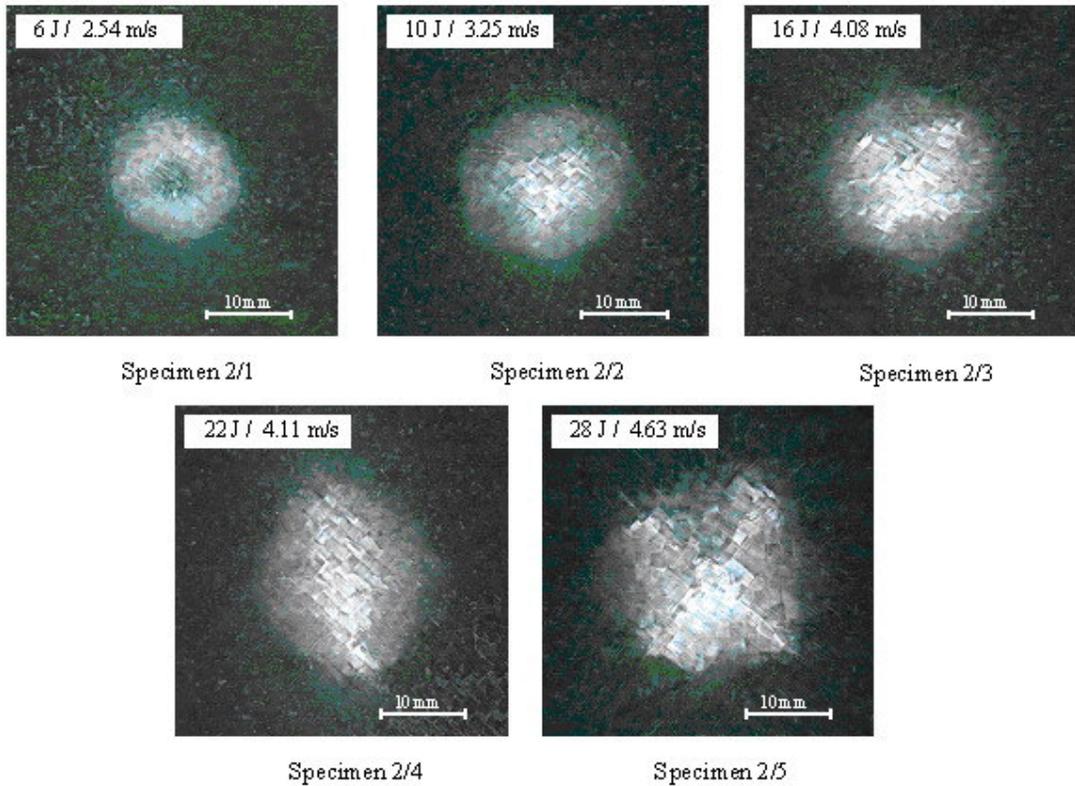
Fig 5. Back face view of woven glass-fiber reinforced composites showing damage modes at respectively

In figure 5 the back-face and internal damage of low-velocity impact tests with nominal impact energies between 16 and 28 J are presented. The back-face damage consisted of a central area of matrix cracking and progressive degradation, and then associated fibre

damage and failure at higher energies. At the very low impact energy of about 6 J obtainable damage is visible. The first signs of damage are matrix cracks, internally or at the back face, which follow the woven pattern of the roving. Regions of debonding and interlaminar damage appear as bright-white zones.

A roughly circular, internal delamination occurs at impact energies of 6, 10 and 16 J, whereas in the case of 22 and 28 J extensive splitting along the fibre direction at the back surface ply resulted in a noncircular damage area. Interlaminar damage occurs at more than one ply interface, but is largest closer to the back-face. With the impacted energy the delamination areas increase gradually. For the 28 J impacted specimens, this internal delamination becomes diamond shaped with the elongating in the warp and weft. At impact energies of 22 and 28 J, back face fibre damage occurs. Due to impact, bending of the laminates causes back-face fibre tensile failure.

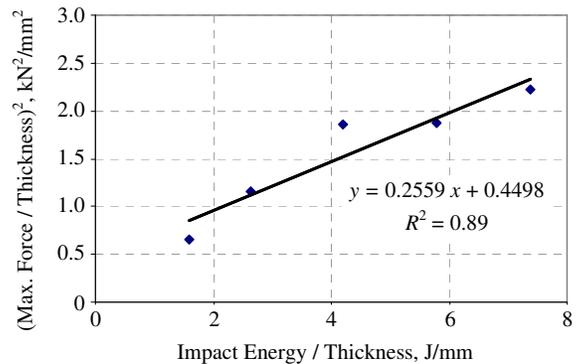
Fig 6. Maximum force normalized with thickness to the impact kinetic energy

The approach taken in the analysis of the results was also used by Zhou and Davies and Sutherland [13, 10]. The maximum force normalized with thickness to the impact kinetic energy is shown in figure 6. For these data,

linear trends are not strong. The limiting of maximum force due to fibre damage at high incident energies is observed.

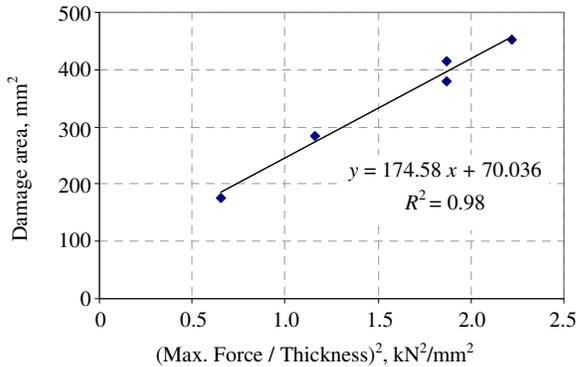
Fig 7. Damage area plotted against the maximum force normalized with thickness

where r is the delamination radius, t is the laminate thickness, and P is the maximum impact force. The damage area in the form of the delamination would extend to the radius, where σ_{zr} exceeds the interlaminar shear strength, τ . High R^2 values (Fig 7) indicate strong linear trends for the woven roving data.
