CONTEXTUAL SEARCHES OF THE ARCHITECTURAL SPACE AND GREEN STRUCTURE OF BAUSKA OLD TOWN

Aija Ziemeļniece

*Department of Architecture and Construction,
Latvia University of Agriculture, Jelgava, Latvia
E-mail: aija@k-projekts.lv*

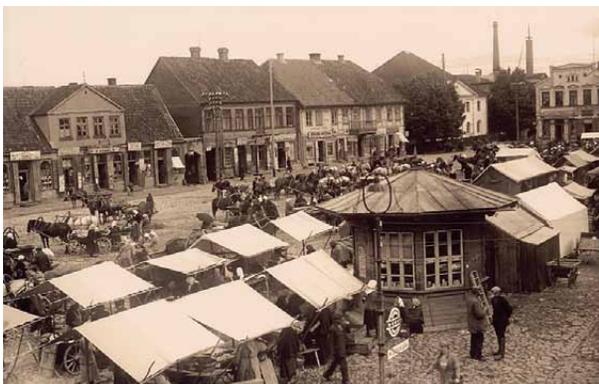
Fig. 1. Perimetral buildings in the Town Hall Square of Bauska along Riga street no trees ('20s of the 20th century). Source: a photo of Local History Museum of Bauska.

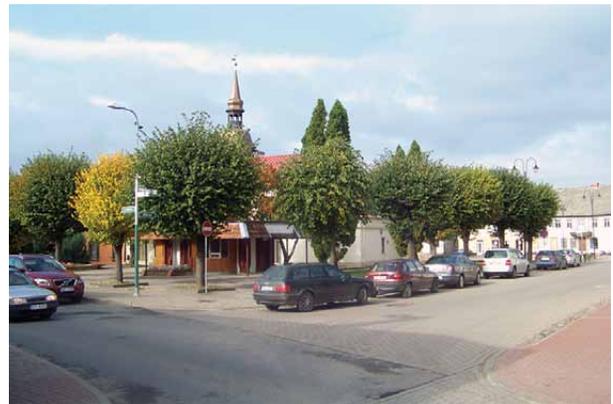
Fig. 2. The southern part of the Town Hall Square is hid by linden tree plantations. Source: author's photo, 2012.

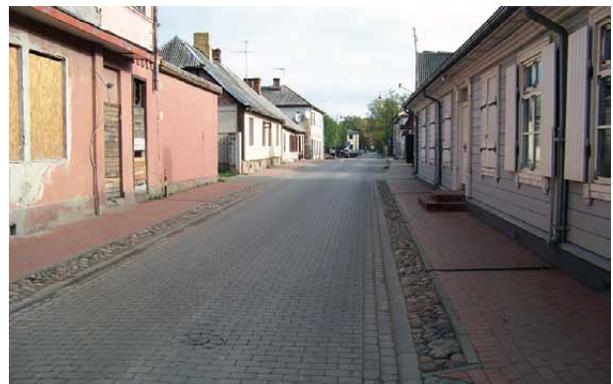
Fig. 3. Plūdoņa street near the Town Hall Square has retained its architectural and historic building structure, with no specific tree plantations. Source: author's photo, 2012.

be used mechanically, i.e. if the cultural environment confirms many criteria, it should not be evaluated automatically as a high priority, but if some of the criteria – as a low priority. Each individual's cultural environment has to be evaluated in comparison and setting priorities. Each specific landscape should be compared to similar cultural landscapes and the solutions should be included in city planning (Jakobsone, Strautmanis 2009). Criteria of setting priorities of the cultural landscape are as follows: priorities are set according to scientific criteria, most representative or most rare features are searched for in the region under the study. Evaluation of the specific cultural landscape approved or not, is based on the criteria: uniqueness, local meaning, characteristics, peculiarity, and level of protection, status of functionality, authentic and historical identity, powerfulness, story, diversity, homogeneity, and harmonization with the natural environment (Fig. 3) (Jakobsone, Strautmanis 2009).

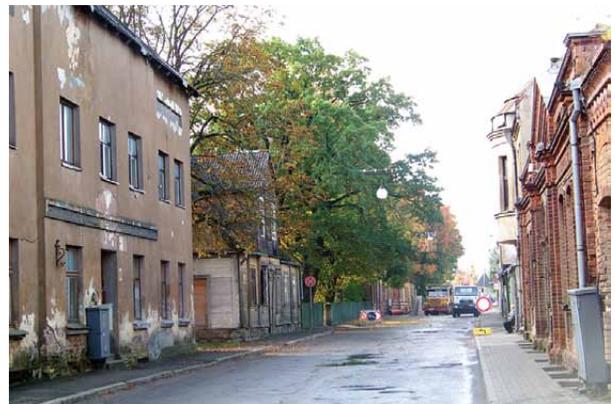
Fig. 5. Instead of the lost wooden buildings in Riga street, there are breaking in huge tree branches hiding buildings of the historical urban environment which disrupts its scale. Source: author's photo, 2012.

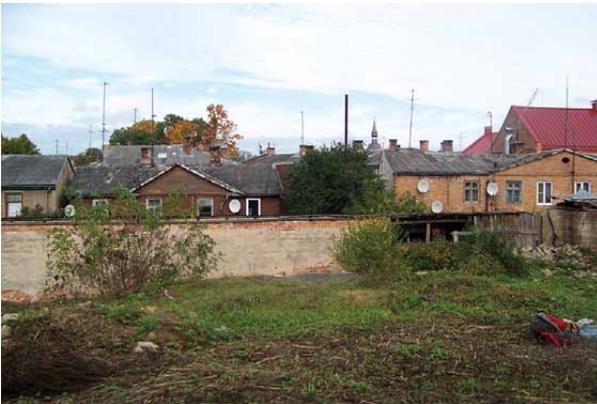
Fig. 6. The roof landscape of the Old Town. *Source:* author's photo, 2012.

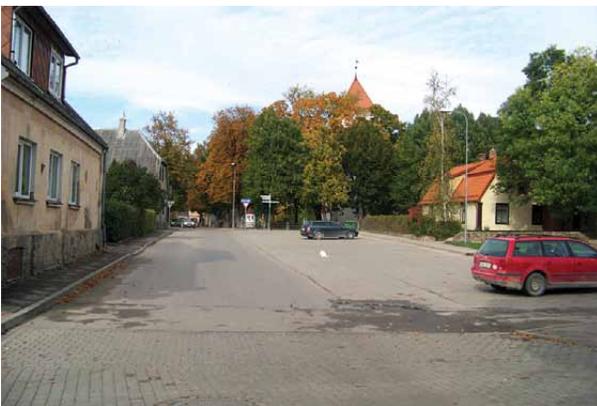
Fig. 7. The huge trees of the garden of the Church of Holy Spirit hide the elegance of the church in the landscape. *Source:* author's photo, 2012.

Therefore, with restoration of the Town Hall, the town has regained one more spire in its silhouette. 200 m away, the bell tower of the Church of Holly Spirit has lost its historical spire's elegance. The simplified quadrilateral pyramid with a tile cover of the tower's roof is partially hidden by immense tree crowns of the church garden which hide the roof landscape of the adjacent block of houses. It is possible to model tree crowns of the church by cutting their branches. In the historical panorama of the Old Town, there is also seen the third dominant – the spire of Mara Church that was lost with burning down Mara Church. The silhouette of the Old Town is seen best of all from the right bank of the Mēmele in Kalna street. Approximately 200 m away from the river, the silhouette of the town is visible only as a small fragment as the view lines are hidden by huge tree groups on both sides of the side street. The silhouette of the entire town with its roofs is exposed only by moving closer to the river, there the height of the view point is lost due to the rise of the ancient river valley.

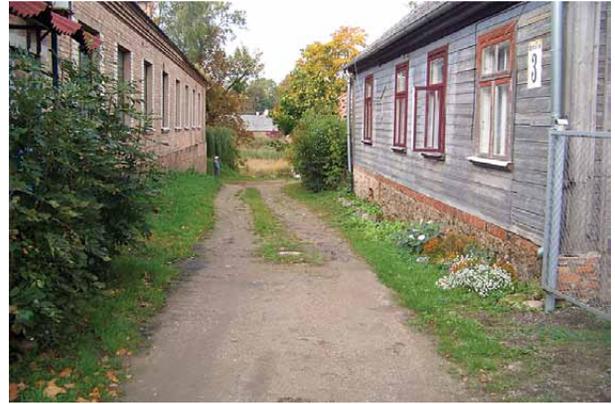
Fig. 8. The historical buildings and character of nature near the bank of the Mēmele. *Source:* 2012, author's photo.

The historical towns of Latvia have been built by developing the local landscape peculiarities and in them we always feel the created mood, organically fusing and considering all the components of the spatial expression (Jakobsone 2011) which increases visually enhanced emotions of the common urban construction space. The intimacy of the ancient parts of historical towns largely depends on a correct choice of the street space scale (Figs. 8, 9).

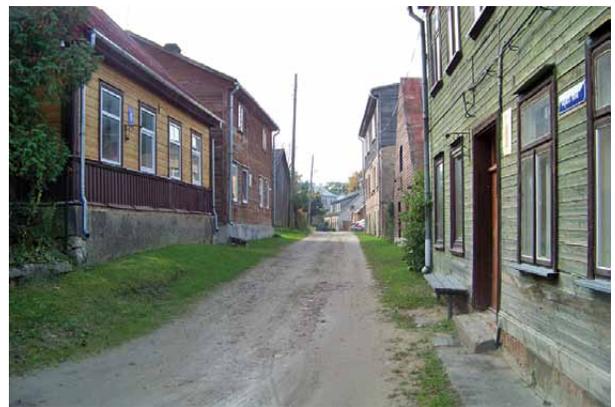
Fig. 9. The historical buildings in Upes street. *Source:* author's photo, 2012.

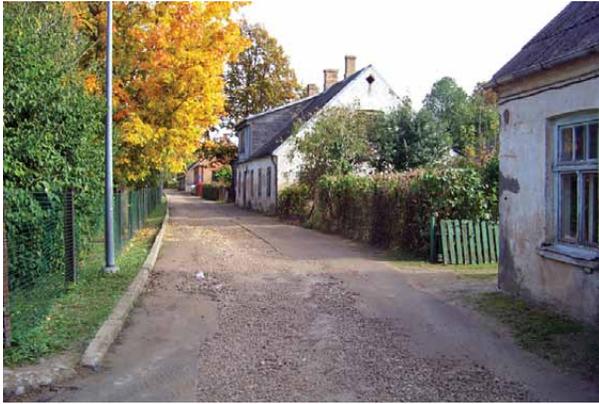
Fig. 10. The spaced historical building and green structure in Kaleju street. Source: author's photo, 2012.

The disappearance of building shape density of the green cover and suppression of the visual perception of the historical building in the main view lines and shape impact of the green structure on the historical scale of the urban environment and roof landscape bring changes (Figs. 10, 11).

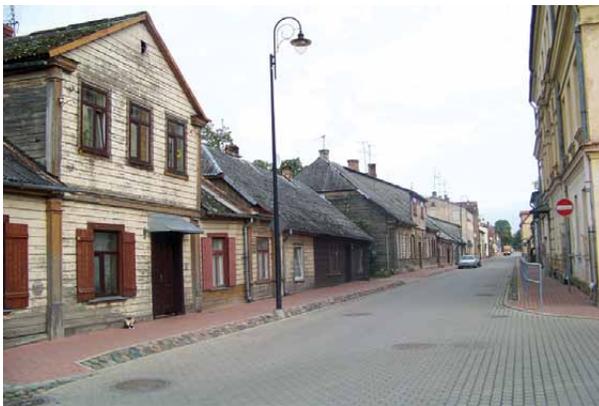
Fig. 11. The building scale in Riga street no trees. Source: author's photo, 2012.
